FLOOD PLAIN INFORMATION

ONTONAGON RIVER ONTONAGON, MICHIGAN

LAKE SUPERIOR SHORELINE ONTONAGON COUNTY, MICHIGAN

PREPARED IN COOPERATION
with
WATER RESOURCES COMMISSION
MICHIGAN DEPARTMENT OF NATURAL RESOURCES
THE VILLAGE OF ONTONAGON
and
ONTONAGON COUNTY
by
DEPARTMENT OF THE ARMY
ST. PAUL DISTRICT CORPS OF ENGINEERS
ST. PAUL, MINNESOTA
SEPTEMBER 1970

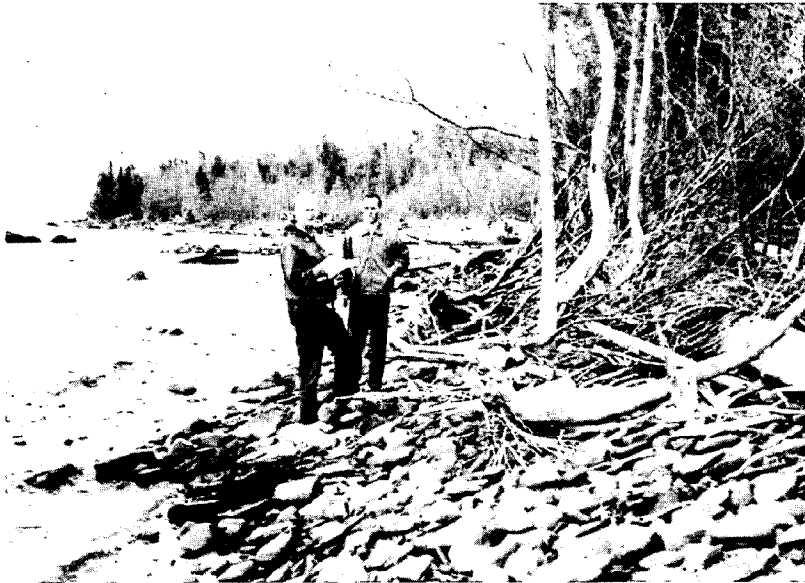
Figure 30. -- TYPICAL SHORELINE - REACH NO. 3

Reach No. 3. East of Union Bay State Highway 107 leaves the shoreline and the sandy beach ends. Figure 30 shows the heavy cobblestone beach which is typical of Reach No. 3. Rocky outcrops have prevented recession for this 3,000-foot reach except for two small embayments.

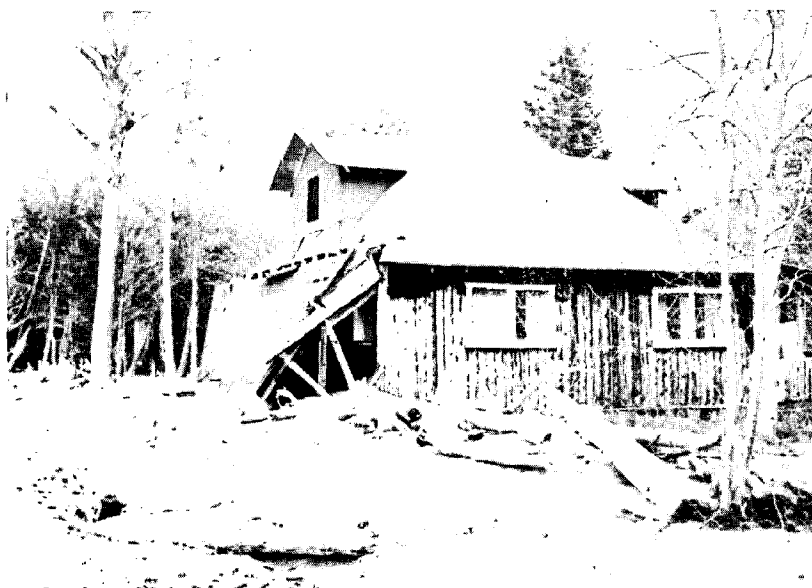
Figure 31. -- PROPERTY DAMAGE - REACH NO. 4

Reach No. 4. This reach extends from the rocky point on the east bank of the Little Iron River to another rocky point 1,800 feet east. Shoreline recession is active here. Several houses are threatened; at least two may be destroyed in the near future. The extent of erosion is depicted by the accompanying photograph (Figure 31) which was taken along Reach No. 4.

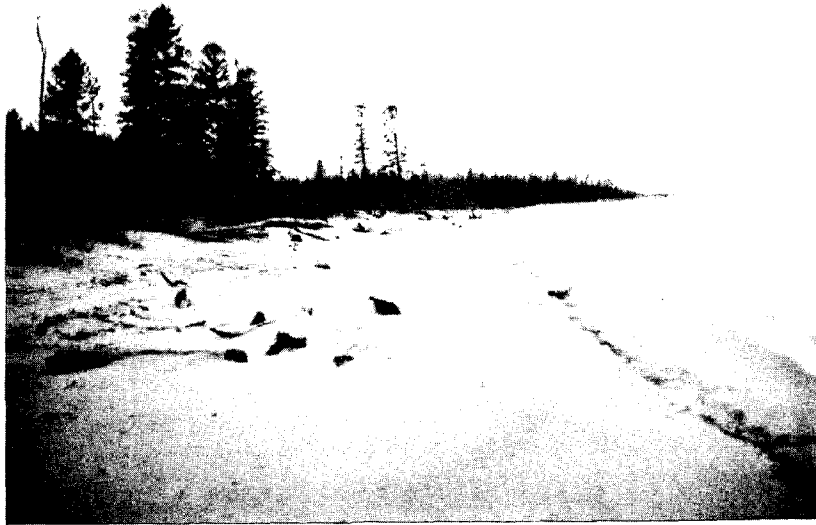
Figure 34. -- TYPICAL SHORELINE - REACH NO. 7

Reach No. 7. This reach extends from Gull Point to a sharp rocky sandstone point about 3,000 feet east. Between these stable points the embayment has reached a depth of 600 to 700 feet. The beach, which is fed by sand size materials deposited by Mineral River, has a substantial width of 75 feet or more, but the up-land is of low relief as shown in the following photograph (Figure 34). The beach berm has been overtopped during storms and sand has occasionally washed back as far as State Highway 64.

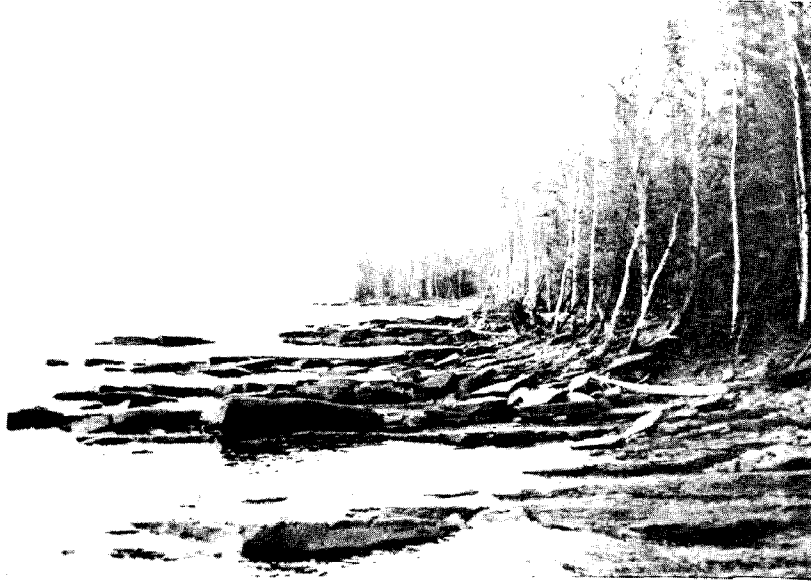
Figure 35. -- EROSION RESISTANT SHORELINE - REACH NO. 9

Reach No. 9. The next 10,000 feet extending almost to the mouth of Stony Creek is armored with a heavy red sandstone shingle which provides a resistant shoreline. A small embayment in the middle of this reach is completely armored. Here the beach is steep and narrow but is all of heavy sandstone shingle. The red sandstone along Reach No. 9 is stratified, fractured, semi-blocky, and dipping lakeward. It appears that these sandstone formations break down into heavy shingle by freezing and thawing activity.

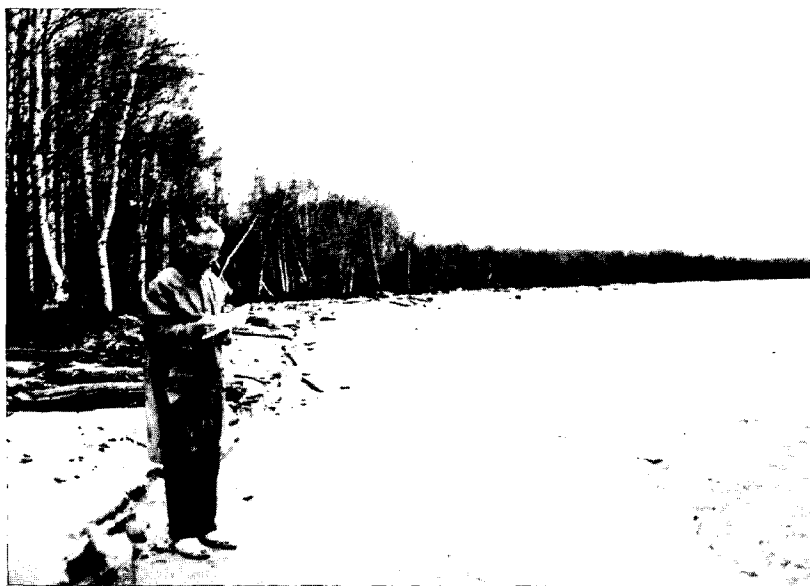
Figure 36. -- TYPICAL SHORELINE - REACH NO. 10

Reach No. 10. The next 2,600 feet of beach centering on Pine Creek is steep and sandy with only about 15 feet wide between the lake and the tree line. Figure 36 is a photograph of a typical portion of Reach No. 10. Pine Creek appears to be a heavy contributor of sand and a delta 100 feet wide has formed at its mouth. Houses at the east end of this embayment are generally located a sufficient distance from the eroding beach and only one appears to be in danger. The beach cross section is similar to that of Reach No. 6 as shown on Figure 33. The eastern 1,000 feet of Reach No. 10 consists of a rocky headland and erosion resistant rocky beach. This is the last such headland for a considerable distance along the coast.

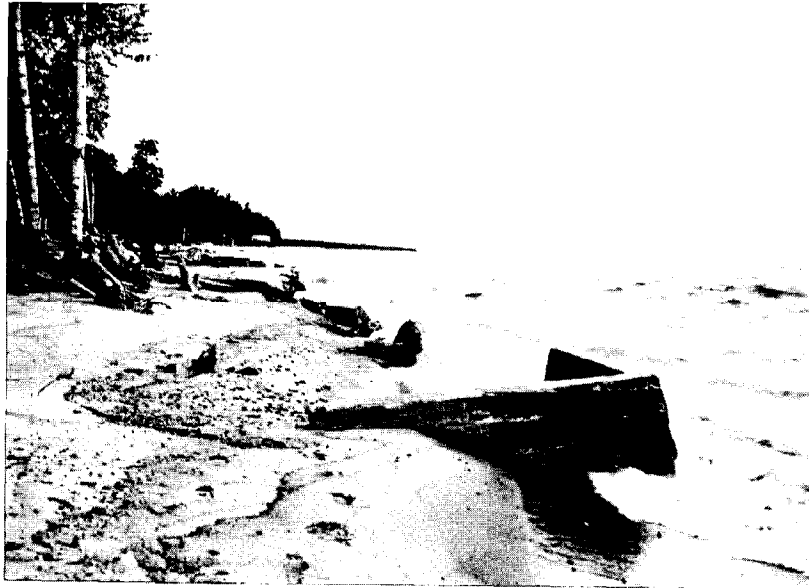
Figure 38. -- MARGINAL SEAWALL INSTALLATION - REACH NO. 11

Further to the west, other localized efforts have been made to prevent building losses and shoreline recession by various types of short seawalls ranging from 100 to 150 feet in length. One typical installation is shown on Figure 38. The seawalls are of various designs including stone filled timber cribs fronted by short groins, stone filled timber cribs with concrete caps, and triangular concrete blocks laid end to end. Substantial maintenance is required as the walls are often overtopped by storm waves. The protection provided by the seawalls is marginal as the shoreline continues to recede on each side of the structures. Additional extensions shoreward at the ends of these walls will become necessary as erosion continues.

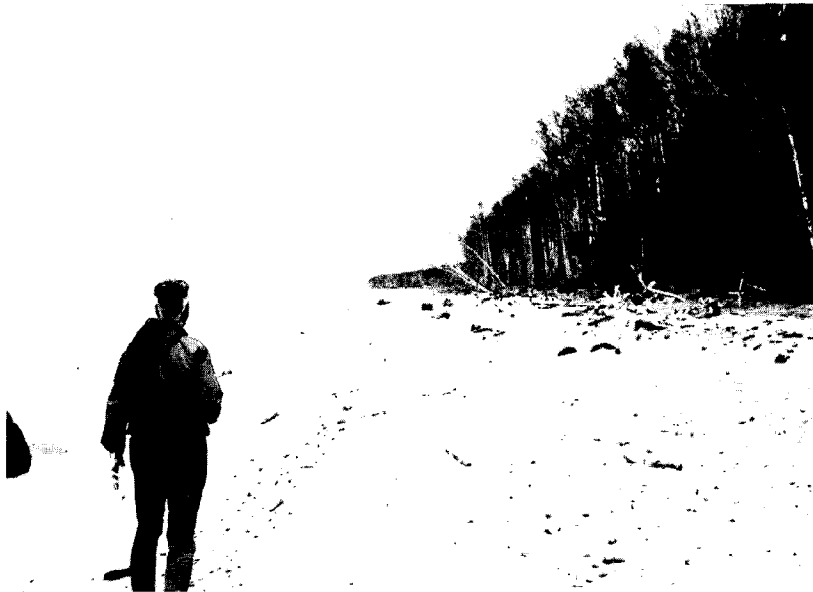
Figure 40. -- TYPICAL SHORELINE - REACH NO. 13

Reach No. 13. From the Cranberry River eastward to the Potato River, a distance of about 9,000 feet, the beach ranges from 80 feet in width immediately east of the Cranberry River to 30 feet in width at the Floodwood River. Basically, the beach steepens as it becomes narrower. A new house was noted under construction near the Floodwood River. This building is located about 30 feet from the top of the beach berm. A typical cross section of this reach of beach is given below on Figure 39. The general appearance of this area is shown in the photograph on the following page (Figure 40).

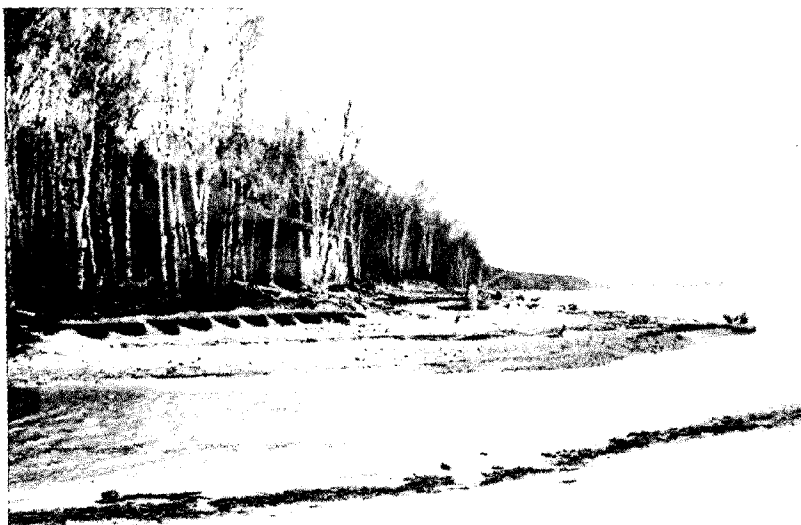
Figure 41. -- TYPICAL SHORELINE PROTECTION - REACH NO. 13

On the west bank of the Potato River a house constructed on the edge of the scarp is protected by rock filled timber crib and old truck tires filled to break up wave action. A photograph of these efforts is included as Figure 41. Similar to the Cranberry River, the Potato River trails to the west denoting a localized long-term net westerly littoral transport.

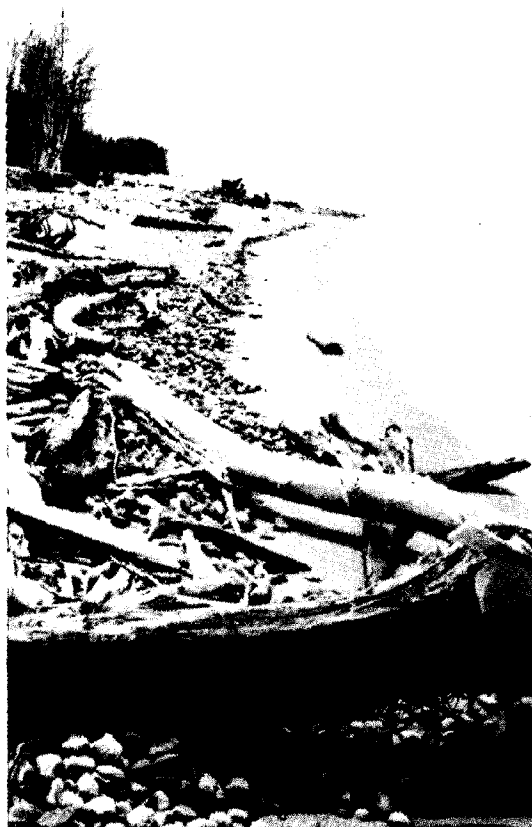
Figure 42. -- TYPICAL SHORELINE - REACH NO. 14

Reach No. 14. From the Potato River to Dreiss Creek, a distance of 5,200 feet, the beach forms a series of shallow scallops having lakeward points consisting of deposits of 3- to 4-inch cobbles (see Figure 42). Otherwise, the beach is uniform, 40 to 45 feet wide, ending in a 2- to 4-foot scarp in friable materials with active recession of the shoreline. Dreiss Creek does not appear to carry much sediment.

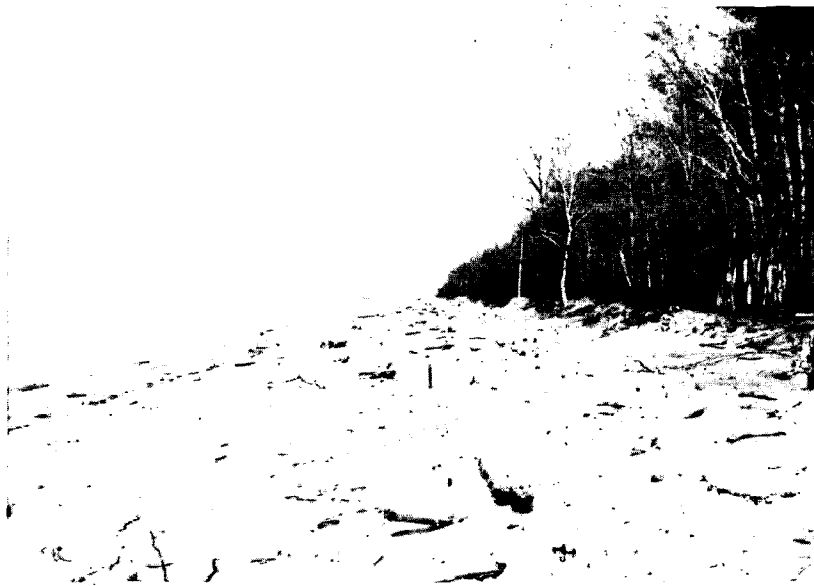
Figure 43. -- TYPICAL SHORELINE - REACH NO. 15

Reach No. 15. This reach includes the 12,000 feet of shoreline from Dreiss Creek to the west jetty at Ontonagon Harbor. For the west half of Reach No. 15, the beach is approximately 70 feet wide as shown on Figure 43 below. Ground elevation is about 8 feet above lake level. At about the midpoint of Reach No. 15, a dragline is used to move sand and gravel from the beach to a stockpile for construction use. A slight scallop is apparent at this point. East of the dragline the beach widens to about 90 feet for the first 3,000 feet and then narrows to not more than 40 feet for the remaining distance to the accretion fillet caused by the west jetty. At locations where the beach is narrow, about 100 feet of dune sand and dune grass lie between the top of the beach berm and the tree line. It is believed that this is the remains of an old relic dune presently being eroded.

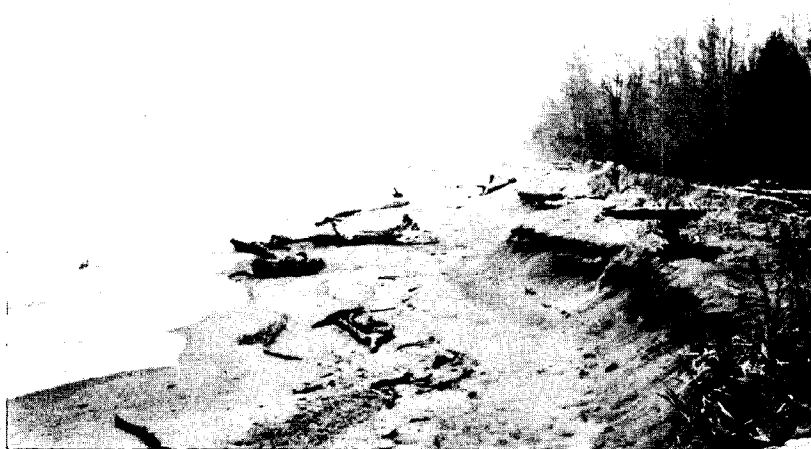
Figure 45. -- NARROW SHORELINE - EASTERN REACH NO. 16

Reach No. 16. This reach includes the shoreline from the Ontonagon River to the west end of Township Park, a distance of about 6,000 feet. The beach fillet and wide beach extend eastward for about 2,000 feet from the Ontonagon Harbor. Figure 44 shows a cross section representative of this area. Further east the beach is typified by a narrow, steep section only 20 feet wide fronting a 2-foot scarp, as shown on Figure 45. The shore is about 6 feet above lake level and is of erodible material. Lake Shore Road lies 120 feet back from the top of the scarp but erosion is active. This condition continues for about 4,000 feet to Township Park.

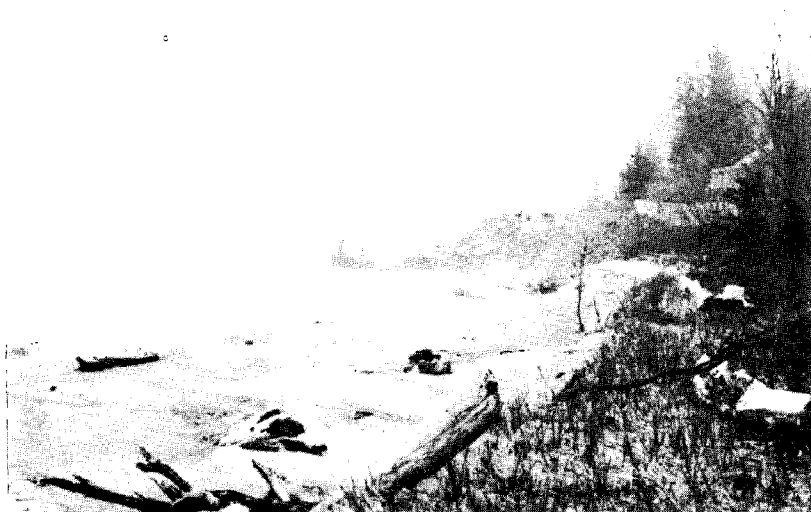
Figure 46. -- LOCAL SHORELINE PROTECTION - EASTERN REACH NO. 16

The remains of an old pier lie 1,000 feet west of Township Park. Between this pier and the park, a house has been protected by a short seawall constructed of broken concrete, brick, stone, and concrete filled tires with two short 10-foot groins constructed of old tires and piles (see Figure 46). The shoreline has receded 15 feet on the west side and 20 feet on the east side of the seawall. While the seawall is holding fairly well, extensions will be required along the sides in addition to periodic maintenance.

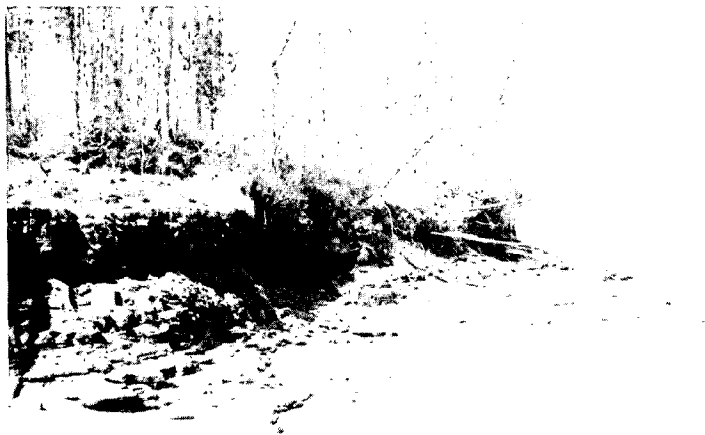
Figure 48. -- TYPICAL SHORELINE - EASTERN REACH NO. 18

The last 7,000 feet easterly to Bear Creek has steep, narrow beaches showing active shoreline recession and outcropping of non-resistant laminated shale formations (see Figure 48). In some of the shale areas, recession is essentially dormant.

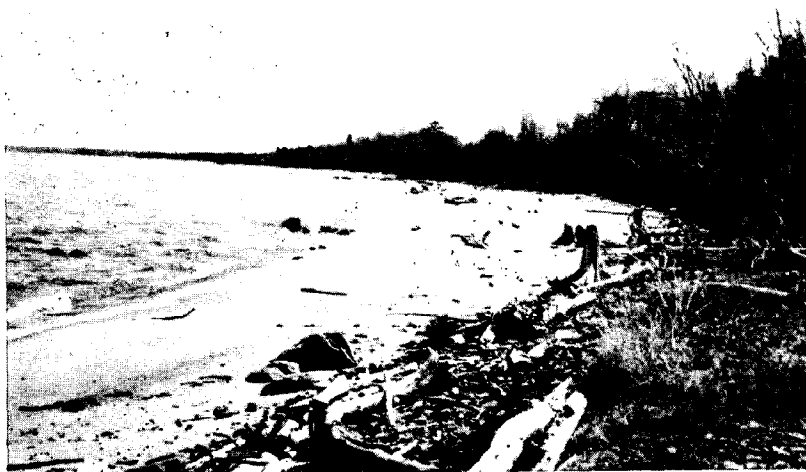
Figure 49. -- TYPICAL SHORELINE - REACH NO. 19

Reach No. 19. The 13,000-foot shoreline from Bear Creek to the Flintsteel River is designated as Reach No. 19. The beach here is uniformly wide as shown on Figure 49 and offers no erosion problem during present lower lake levels. Net littoral movement in this area is from west to east as evidenced by Bear Creek which trails to the east.

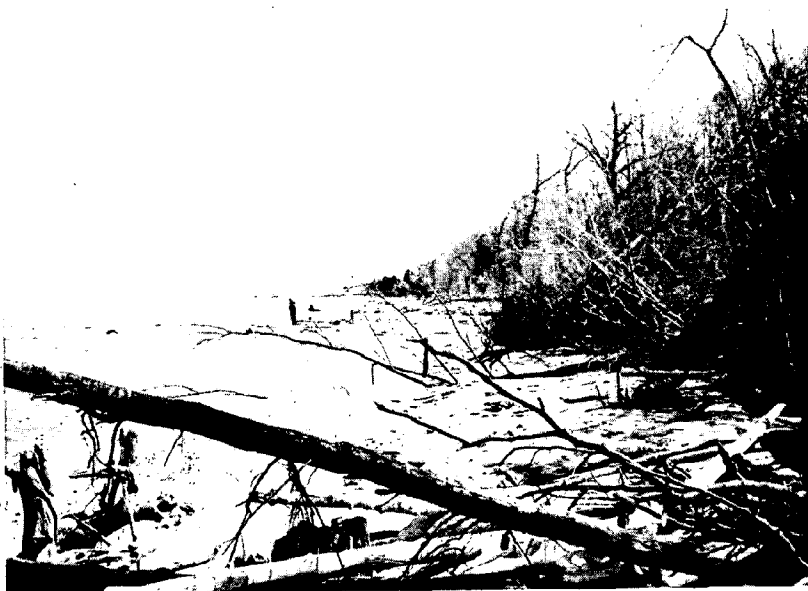
Figure 50. -- TYPICAL SHORELINE - WESTERN REACH NO. 20

Reach No. 20. From the Flintsteel River to the east end of the "West Coast" study area is about 7,000 feet. The beach through the west part of this reach averages about 50 feet in width fronting a 4- to 5-foot scarp of easily erodible material (see Figure 50). Farther east the beach narrows and steepens to a width of about 35 feet with a 1- to 2-foot scarp. A typical section in this reach is sketched as Figure 51.

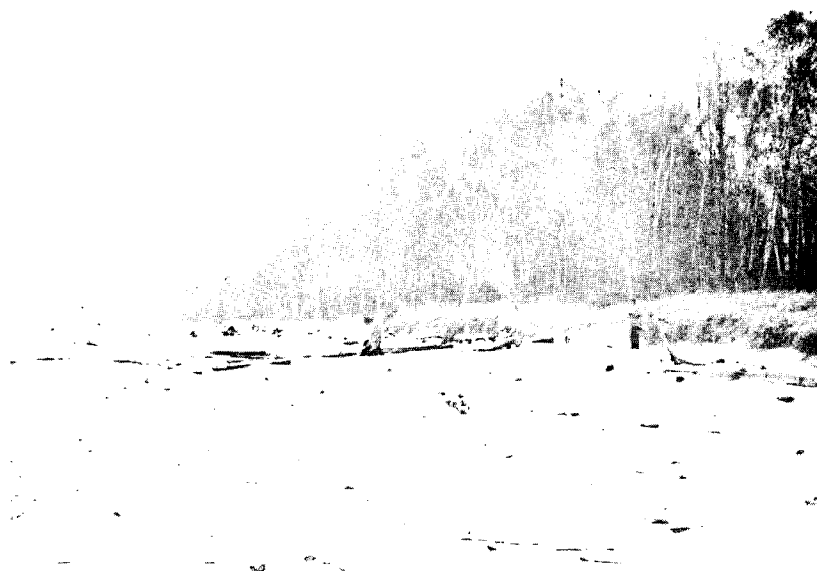
Figure 52. -- TYPICAL SHORELINE - WESTERN REACH NO. 21

For the first 2,000 feet east of Misery River the beaches are up to 125 feet wide fronting a low water berm and a 2-foot scarp. The elevation of the coast is 10 to 12 feet above lake level. Evidence of sand dune formation is apparent. Figure 52 is a photograph of this area.

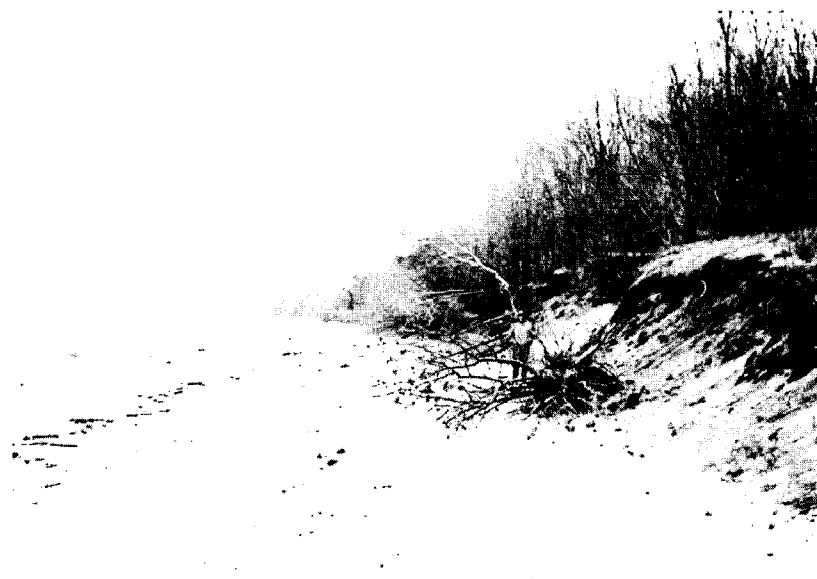
Figure 53. -- TYPICAL SHORELINE - EASTERN REACH NO. 21

Beyond the first 2,000-foot section of Reach No. 21, the beach narrows to widths ranging from 30 to 50 feet. The adjacent bluffs range from 5 to 35 feet in height with the greatest height at the eastern end of the study area. The upland is comprised of relic sand bars that are easily eroded. A typical portion of this beach is shown on Figure 53.

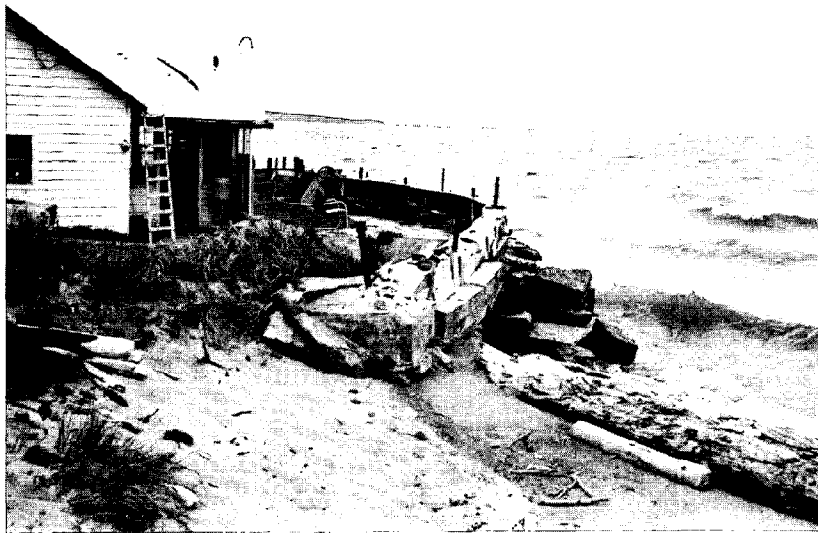
Figure 58. -- CONCRETE AND ROCK SEAWALL

A number of private structures has been constructed particularly in the vicinity of Green and to a lesser extent near Ontonagon. Seawalls ranging in length from 100 to 250 feet have been constructed to a great variety of designs including concrete wall, precast concrete shapes, rock-filled timber crib, composite crib and concrete construction, concrete blocks, and miscellaneous mixtures of random stone, broken concrete, bricks, and old tires filled with concrete. Photographs of typical privately constructed seawalls are included on Figures 58 through 60.

Generally, the privately constructed coast protection works are poorly designed and constructed and do not enhance the appearance of the area. Lacking support of similar construction on adjoining property they soon become isolated headlands vulnerable to destruction from the flanks.

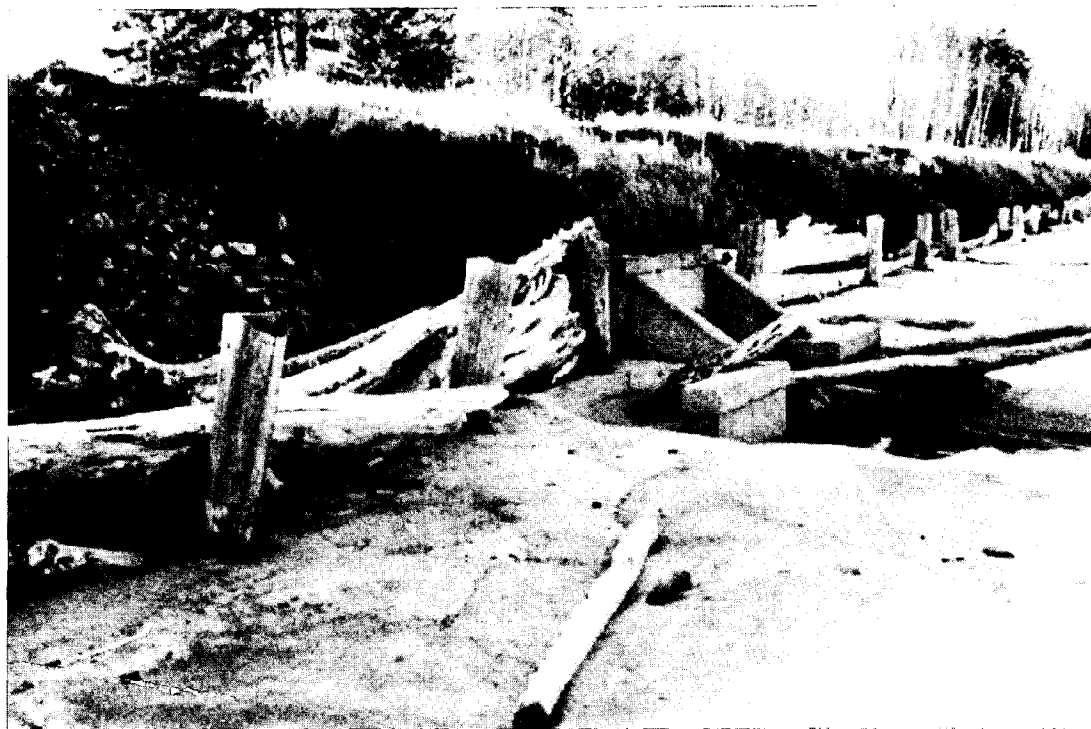
Figure 63. -- SHORE EROSION SCENES IN ONTONAGON COUNTY - DECEMBER 1968

Top view is looking west toward the Porcupine Mountains from the Union River adjacent to Union Bay. The State Highway 107 sign gave way to Lake Superior shortly after this photograph was taken. Lower view shows the result of damages along this same section of highway.

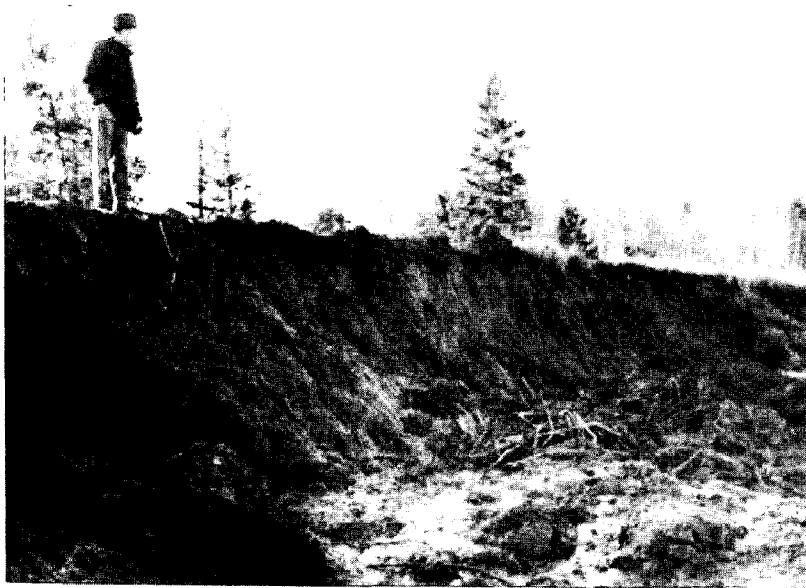
Figure 64. -- SHORE EROSION SCENES IN ONTONAGON COUNTY - DECEMBER 1968

The man in the upper photograph is standing on State Highway 107 adjacent to Union Bay. Lower view shows erosion damage and debris washed ashore at a cottage near Green, Michigan.

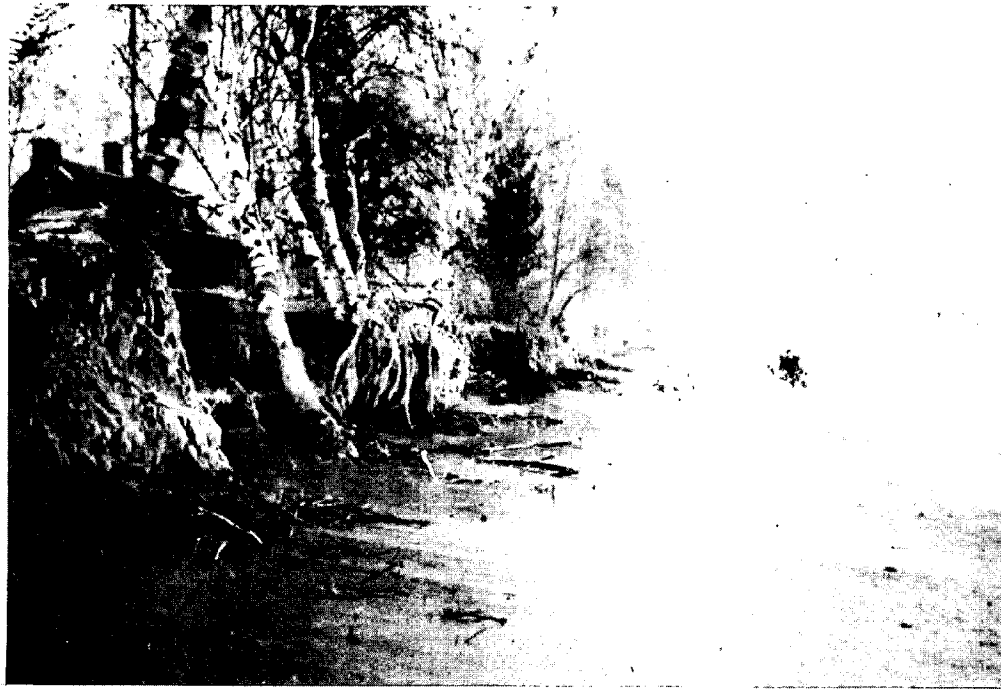
Figure 65. -- SHORE EROSION SCENES IN ONTONAGON COUNTY - DECEMBER 1968

Top view shows failure of locally attempted shore protection measures at a property west of Ontonagon. Bottom photograph was taken along the beach near the mouth of the Big Cranberry River. The large birch trees, which were uprooted by Lake Superior erosion, were located on the Wallace Jarvi property.

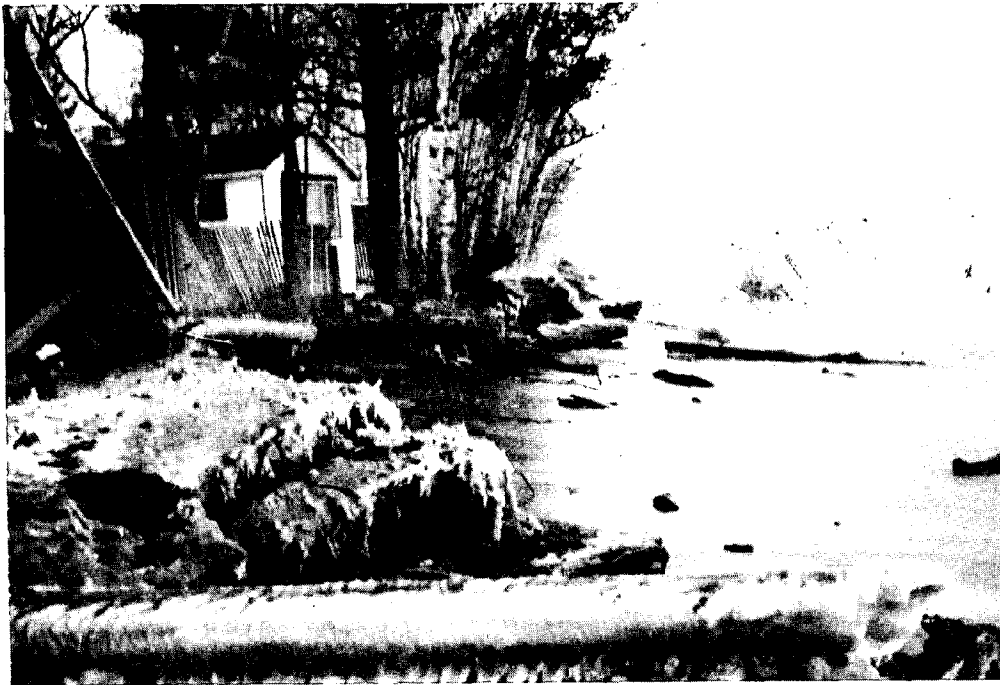
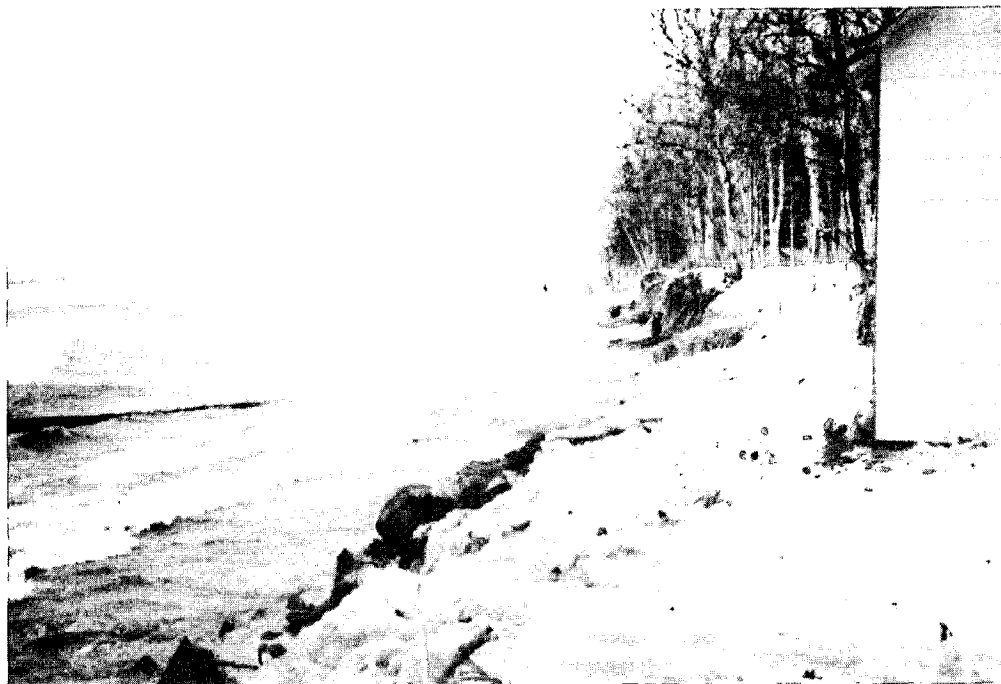
Figure 66. -- SHORE EROSION SCENES IN ONTONAGON COUNTY - DECEMBER 1968

Top photograph was taken at the Kirouac property at Green. Lake Superior has gouged deeply into this property and has undermined several cottages as well as destroyed trees. Lower view shows Lake Superior shoreline threatening a building approximately four miles west of Ontonagon.
